Manhole Inspection Summary

Manhole # S21GG_025MH

Insp Date: **6/15/07 7:59 AM**

Location Address: **1818 PRESSTMAN ST**

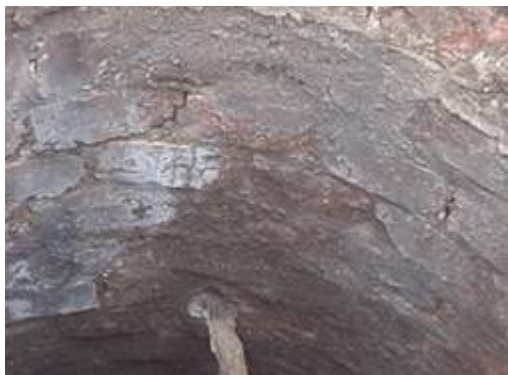
Defect 4

Condition: ☐ Sound ☐ Cracked ☐ Root Intrusion ☐ Loose Brick ☒ **Deteriorated**

Infiltration: ☐ None ☐ Joint ☐ Cracks ☐ Mortar ☐ Roots ☒ **Wall**

INFILTRATION OF CORBEL

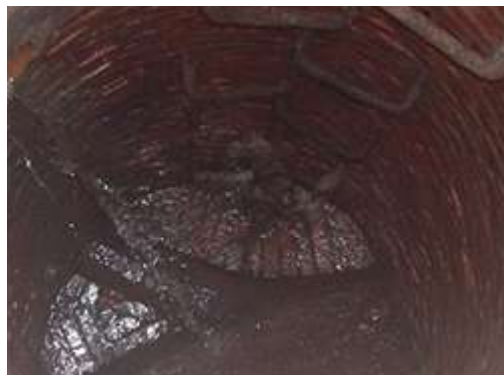
Defect 3

☒ **Evidence Of Surcharge** Depth: **6** (ft.) ☐ Active Surcharge Present

SURCHARGE EVIDENCE OF STEPS

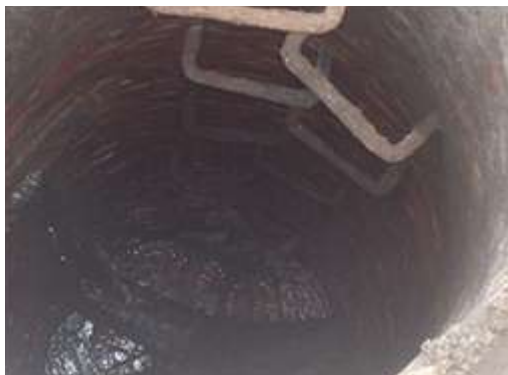
Defect 2

Count: **9** Missing: **0** ☒ **Corroded**

CORRODED STEPS

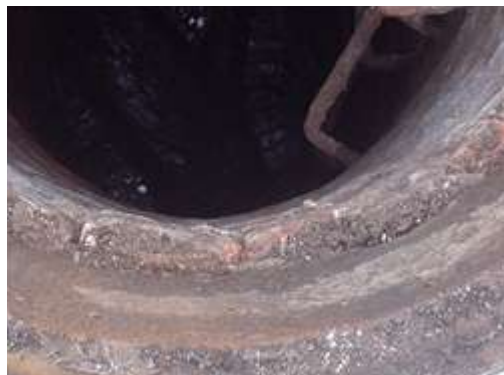
Defect 1

Offset: **1** (in.)

FRAME OFFSET AND DETERIORATION
OF CORBEL

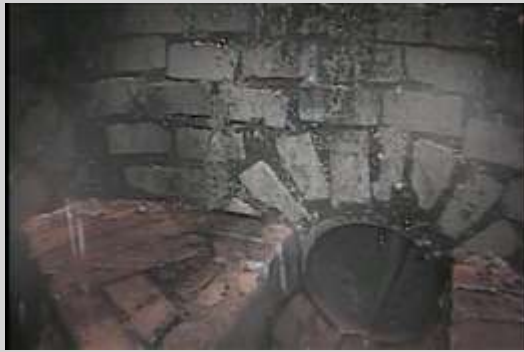
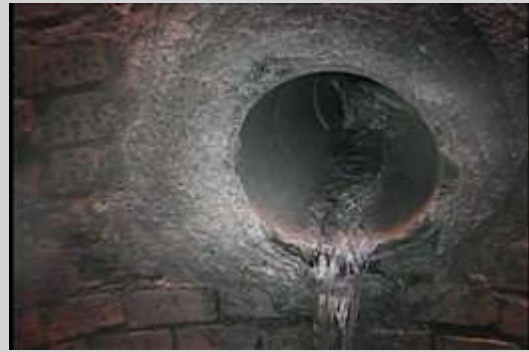
8 O'Clock Inflow

Comments **i8 pipe is clogged pouring water into bench**

Drop Condition: **Clogged**
